FEB 79 M BAKER

Name of Dam: Dry Run No. 102

Inventory Number: VA 13901

PHASE I INSPECTION REPORT
NATIONAL DAM SAFETY PROGRAM

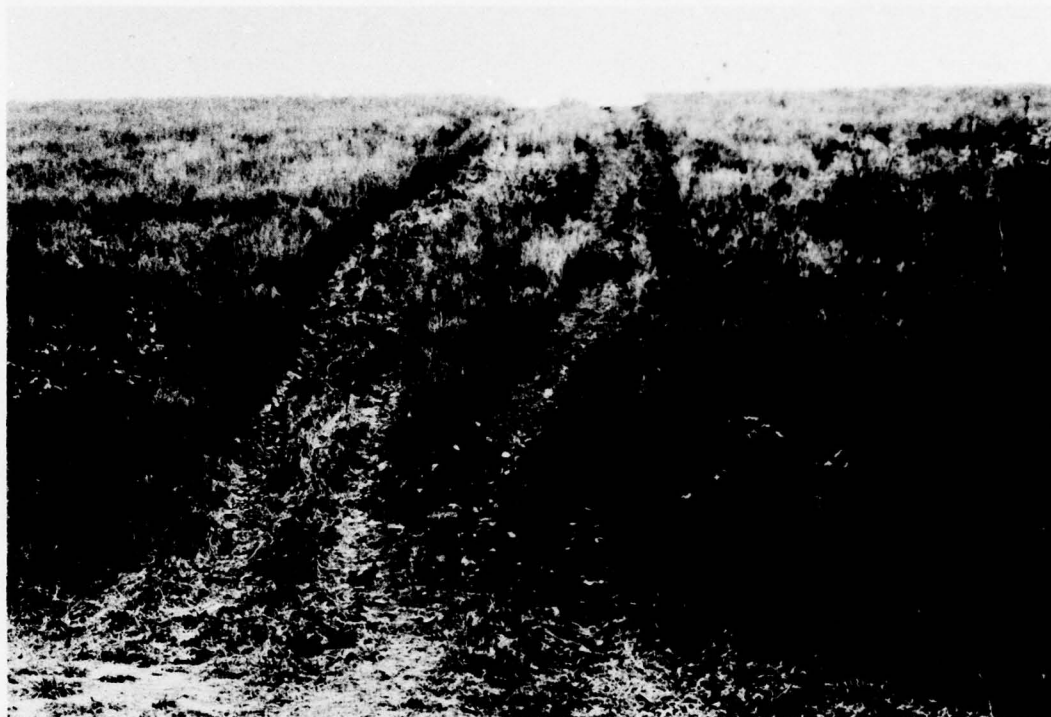
- 3.1.2 Dam: The embankment was generally in good physical condition. No cracks, unusual movement, sloughing, excessively deep erosion or seepage was observed on the embankment or abutments. There are several bare areas namely: vehicle tracks on the downstream slope of the dam and spillway slope, a path on the upstream slope near the riser (see Photo 2), and roadway tracks at the crest on the left side. There are scattered dried out patches of grass and wood debris in the lower 20 feet of the upstream slope. Small trees and brush have grown in the rock toe drain and rock slope gutters (see Photo 5).

3.2 Evaluation: The only serious deficiency is the erosion in the tire tracks resulting from operation of vehicles on the downstream slope on the left side of the outlet works (see Photo 1). Topsoil should be placed in the bare areas and planted with grass seed. The access for vehicles should be blocked-off to prevent this problem from re-occurring. If restriction of vehicular traffic is not possible, then some means of embankment protection should be implemented.

PHOTO 1. Eroded Vehicular Tracks on Downstream Slope

- 7.2 Recommended Remedial Measures: The filling and reseeding of the tire tracks on the embankment should be repaired without delay to prevent erosion. Also, some means from preventing further vehicular traffic on the embankments should be considered immediately. If restricting vehicular traffic is not possible, a means of protecting the embankment against erosion should be implemented. The inspection revealed certain maintenance items listed below which should be scheduled during the annual maintenance period.

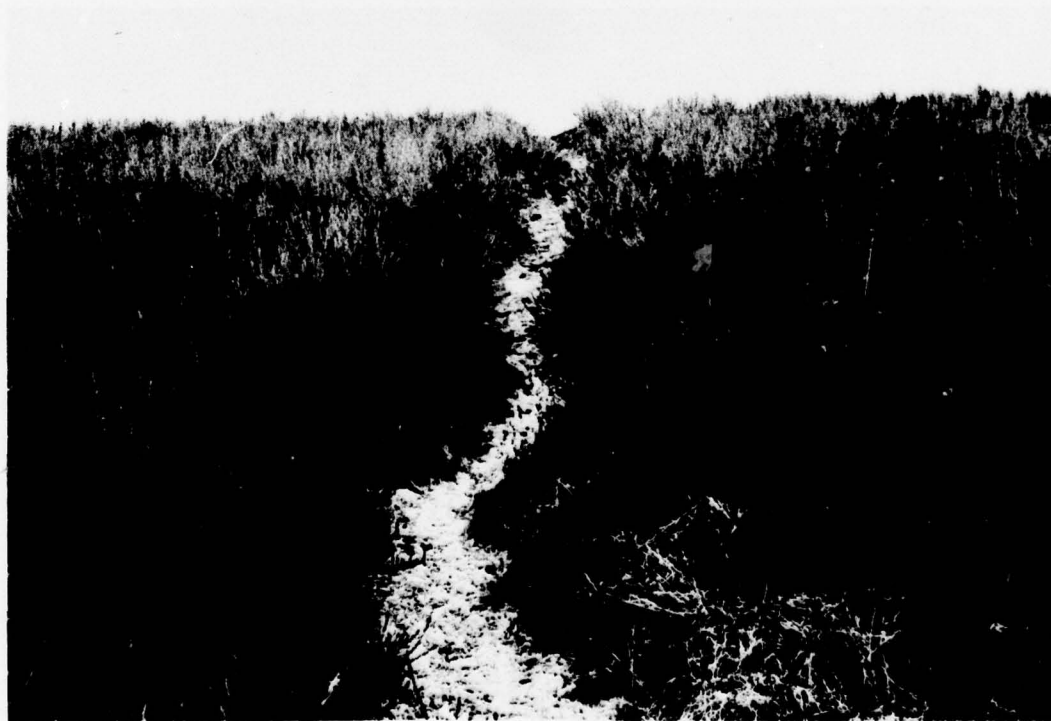
PHOTO 2. Footpath on Upstream Slope (Near Riser)

- 1) Cut all tree growth on embankment and rock toe drains.
- 2) In addition to areas already noted, reseed all bare areas on the embankment including footpath on the upstream side.
- 3) A staff gage should be installed to monitor reservoir elevations above normal pool.

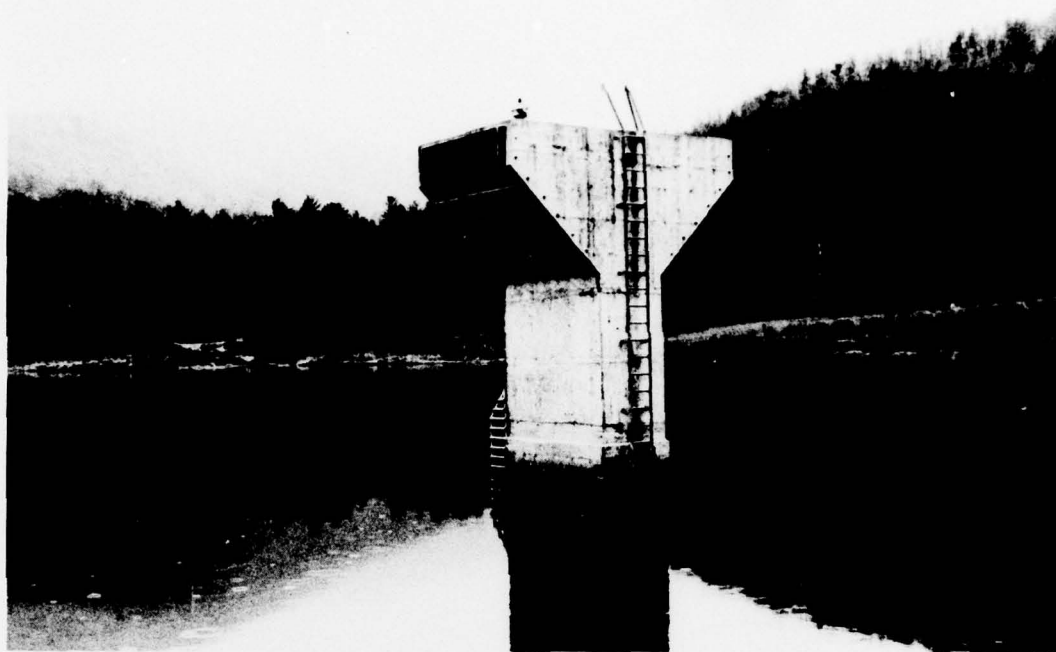
- 3.1.3 Appurtenant Structures: No structural deficiencies were observed (see Photo 3).
- 3.1.4 Reservoir Area: No serious deficiencies were observed in the reservoir. A staff gage should be installed to monitor reservoir elevations above normal pool.

PHOTO 3. View of Riser From Upstream Face of Dam

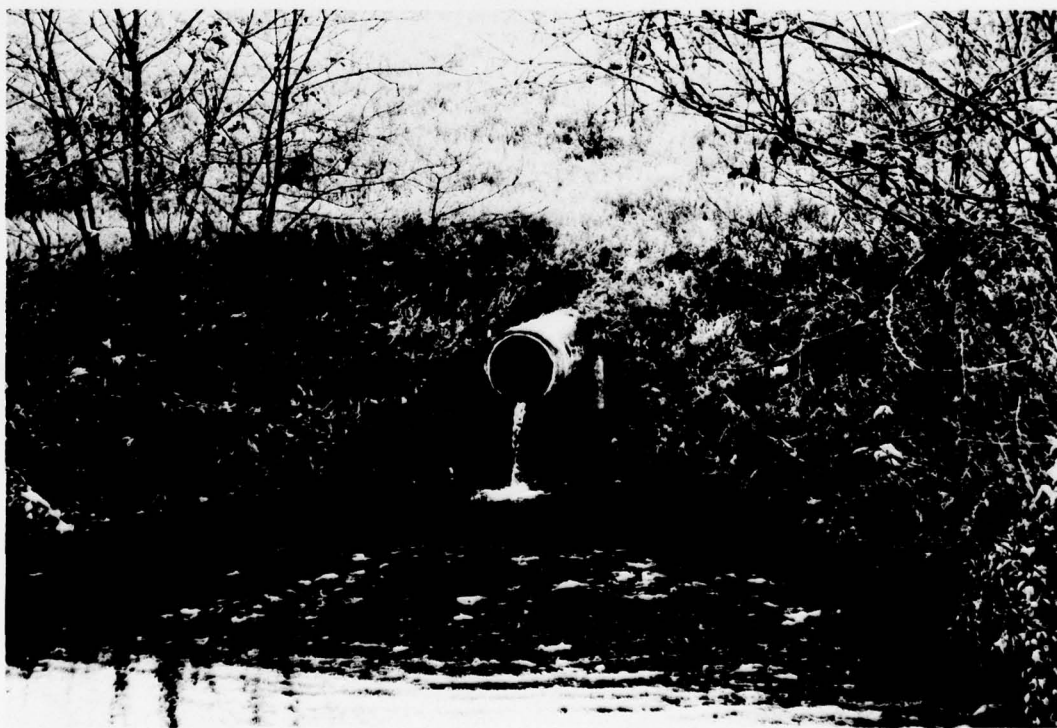
- 3.1.5 Downstream Channel: The stilling basin and outlet channel are functioning properly and the riprap is in good condition (see Photo 4).

PHOTO 4. Outlet Pipe and Stilling Basin

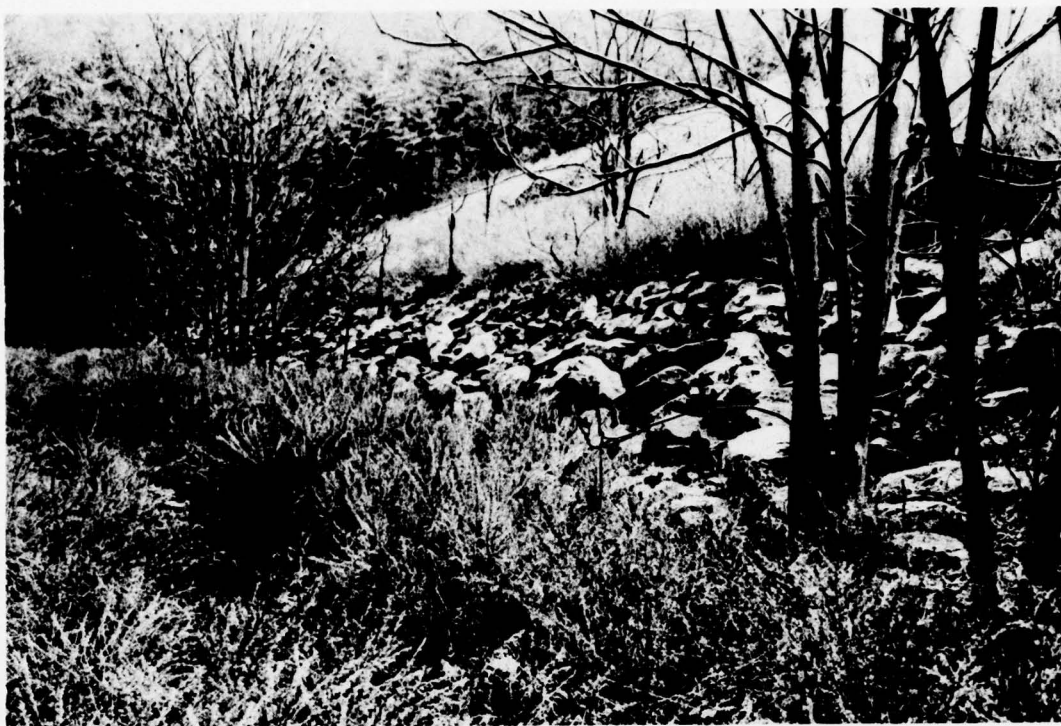
PHOTO 5. Rock Toe on Downstream Side of Dam

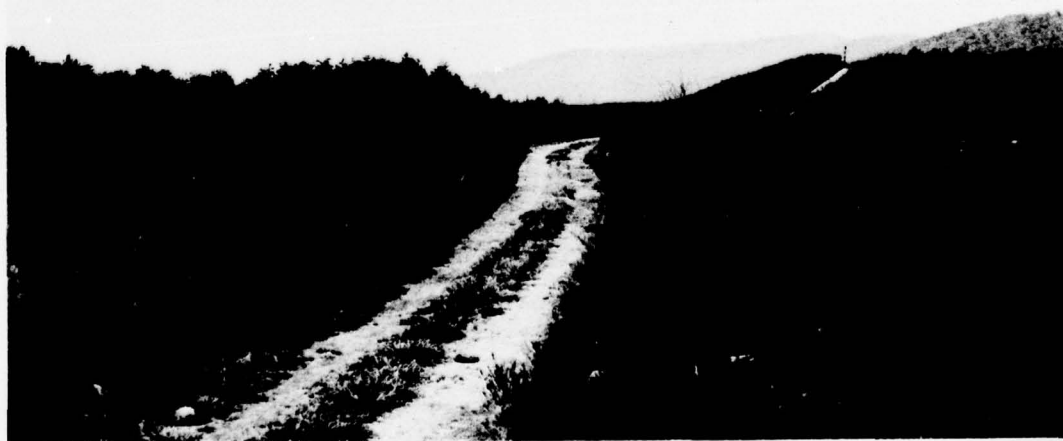
PHOTO 6. Emergency Spillway and Left Abutment
